Colonial Williamsburg Archaeological Reports

Archaeological Excavations on the Tazewell Hall Property

May 15, 1986
Re-issued July 2001

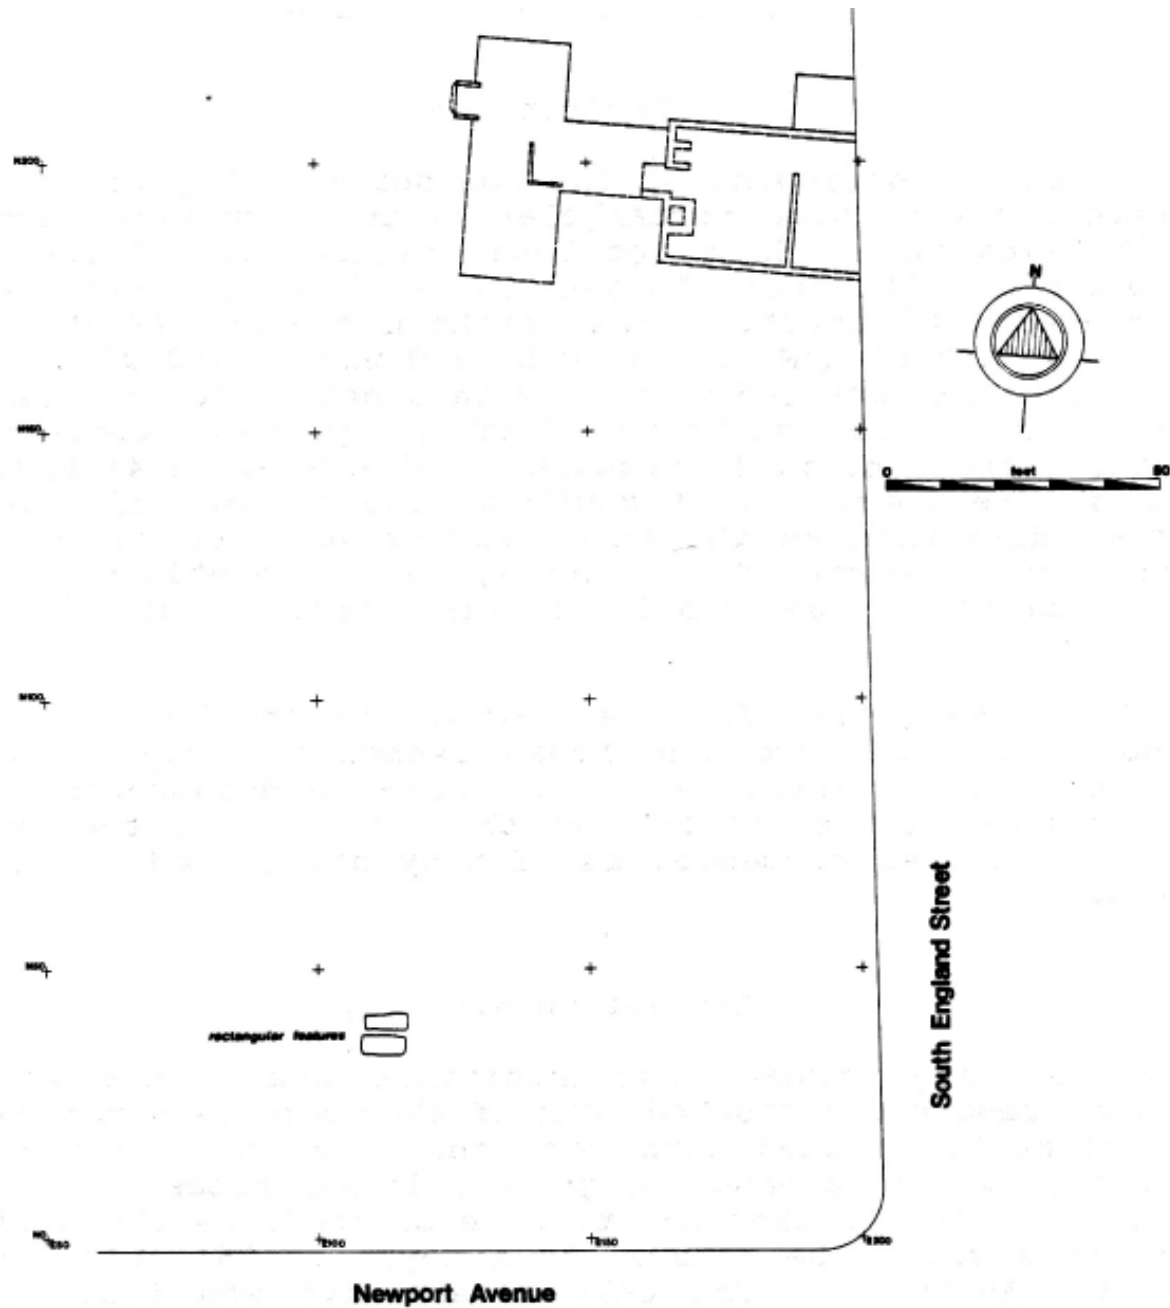
Figure 33. Location of the two rectangular features.

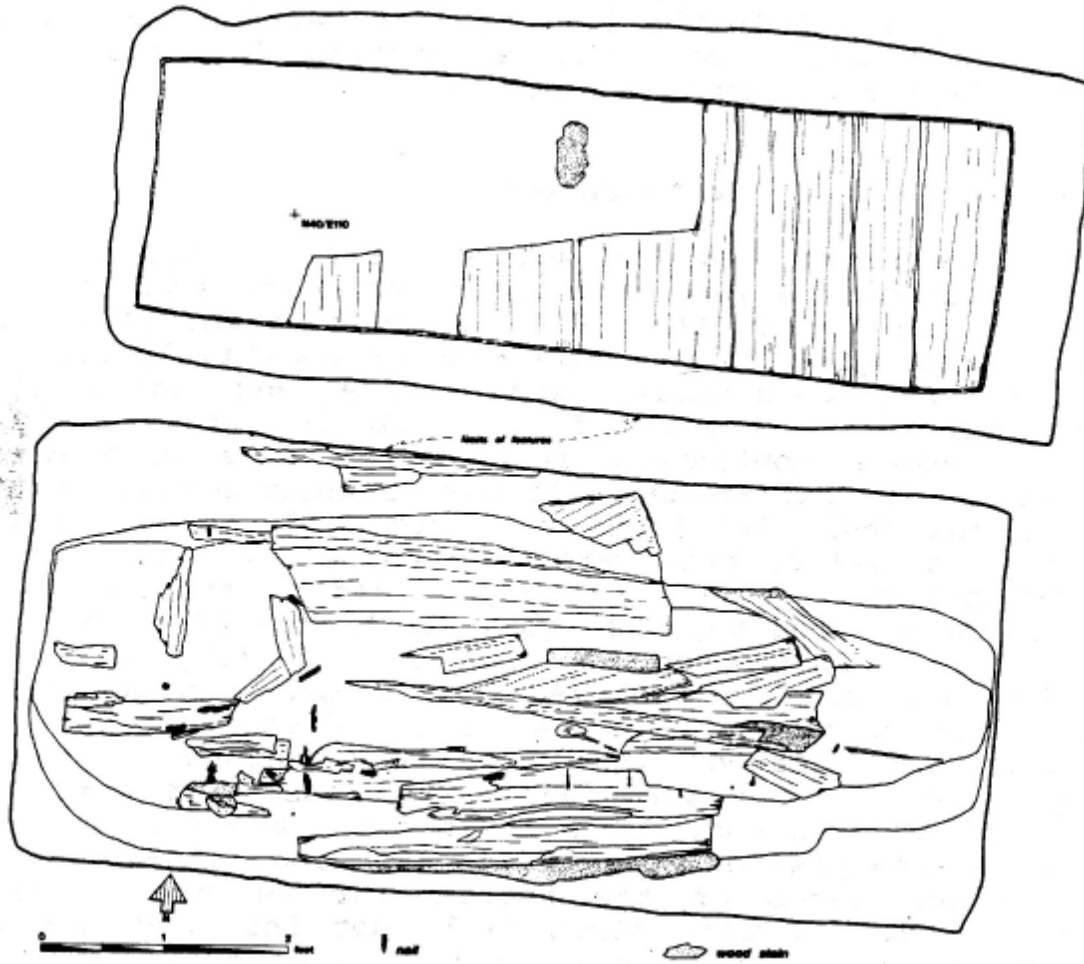
Figure 34. Plan view of northern and southern rectangular features.

During the removal of the southern half of Master Context C02, a small piece of a long bone shaft was discovered at a depth of 0.5' below the top of the hole. Excavation was halted until staff zooarchaeologist Joanne Bowen-Gaynor positively identified the faunal material as a medial section of a long bone shaft from a pig (*Sus scrofa*). Removal of the yellowish brown silty clay (44B-363 and -364) continued, revealing a hole with straight sides. Numerous machine-made nails were dispersed throughout the silty clay, and their locations were recorded. Other artifacts included English delft, pearlware, and Chinese export porcelain, with a *terminus post quem* of 1805 provided by the machine-made nails. A piece of wood appeared at a depth of 1.6' below the top of the feature. This wood, a 3.3' × 0.3' fragment of what appeared to be a roughly finished 1.5" board, was set slightly askew on the perimeter of a soil discoloration. This discoloration was located 0.15' from the southern edge of the feature (Figure 34) and extended to the east and west within 0.07' to

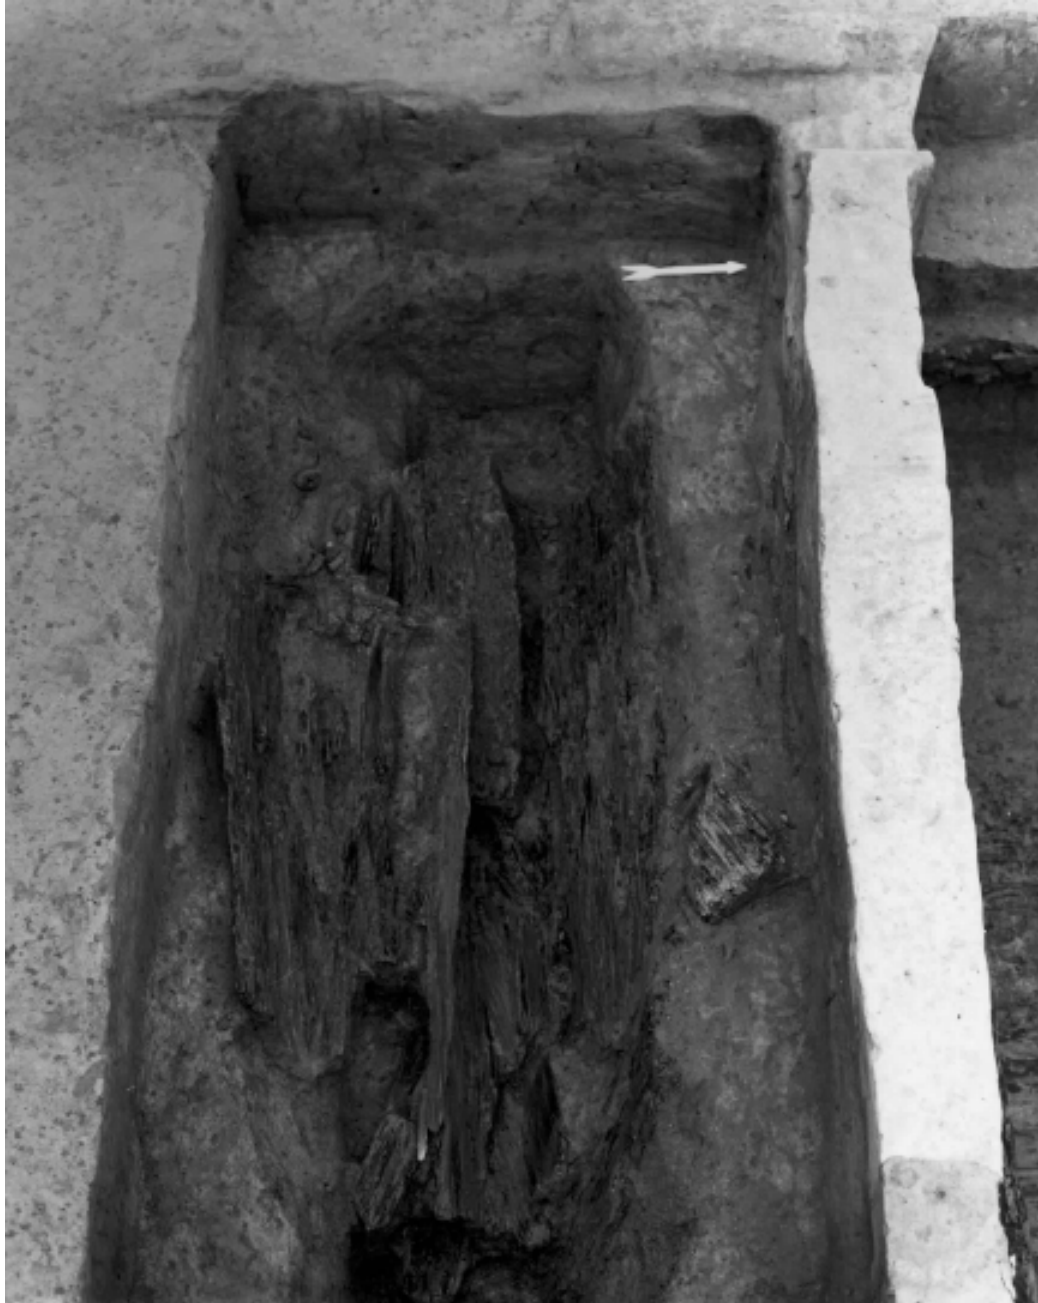
Figure 35. Disarrayed wood in bottom of southern feature.

When all the silty clay fill was removed, the outlines of the wood-filled pit were fully visible. The loamy sand discovered in and around the wood was thoroughly mixed with the wooden planks, covering some and underlying others. Cutting through the loamy sand and wood at the western edge of the feature was an oval soil stain (44B-470). This turned out to be an intrusive feature, the fill of which was composed of the same silty clay as the layer above it, and its filling presumably dating to the same time as the deposition

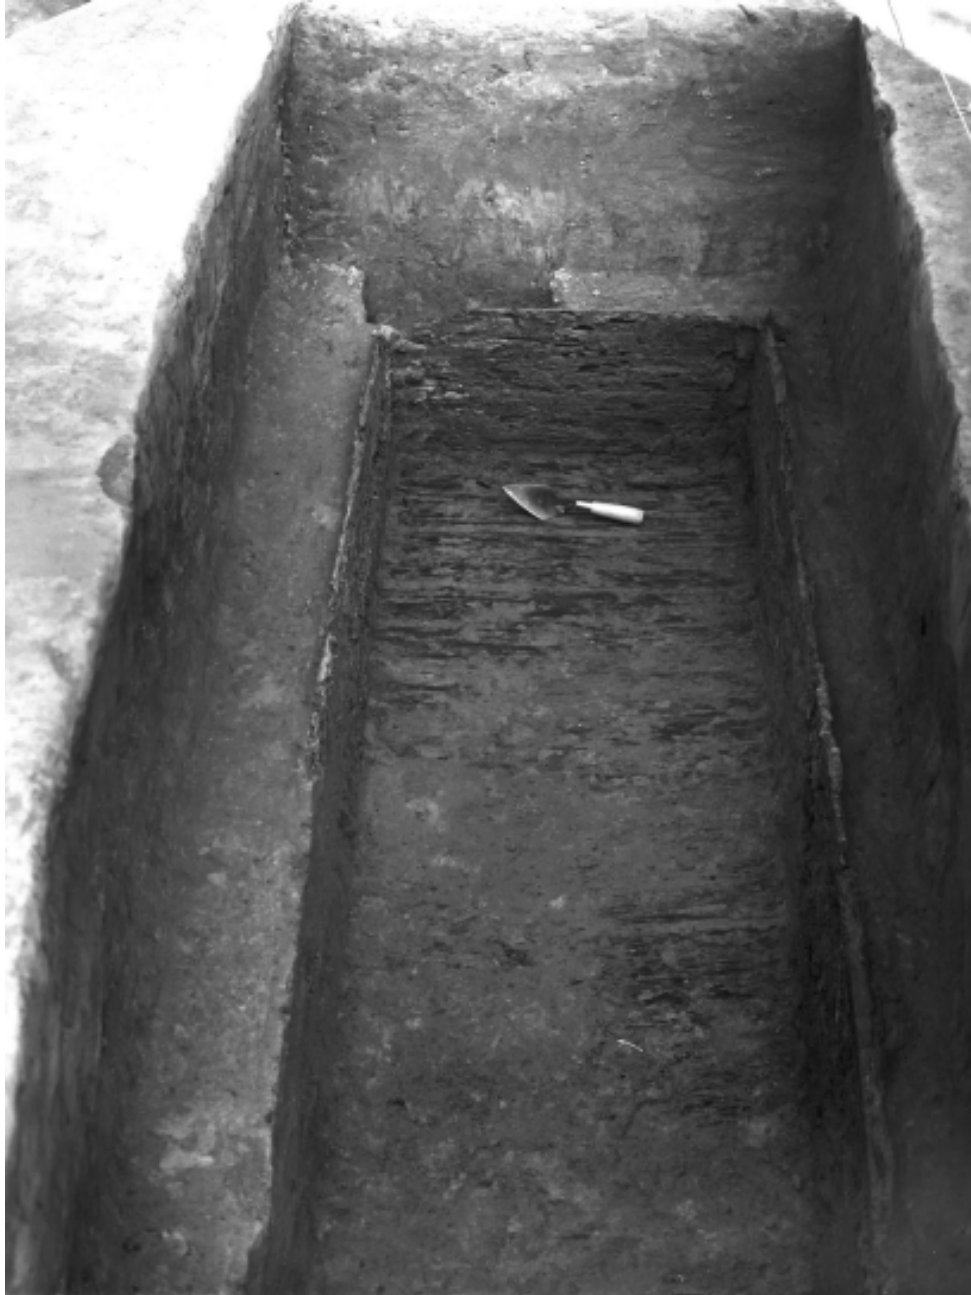
Figure 36. Wooden box in northern feature.

Excavation of the eastern half of the pit was then begun. The wooden lid of the box, more in-

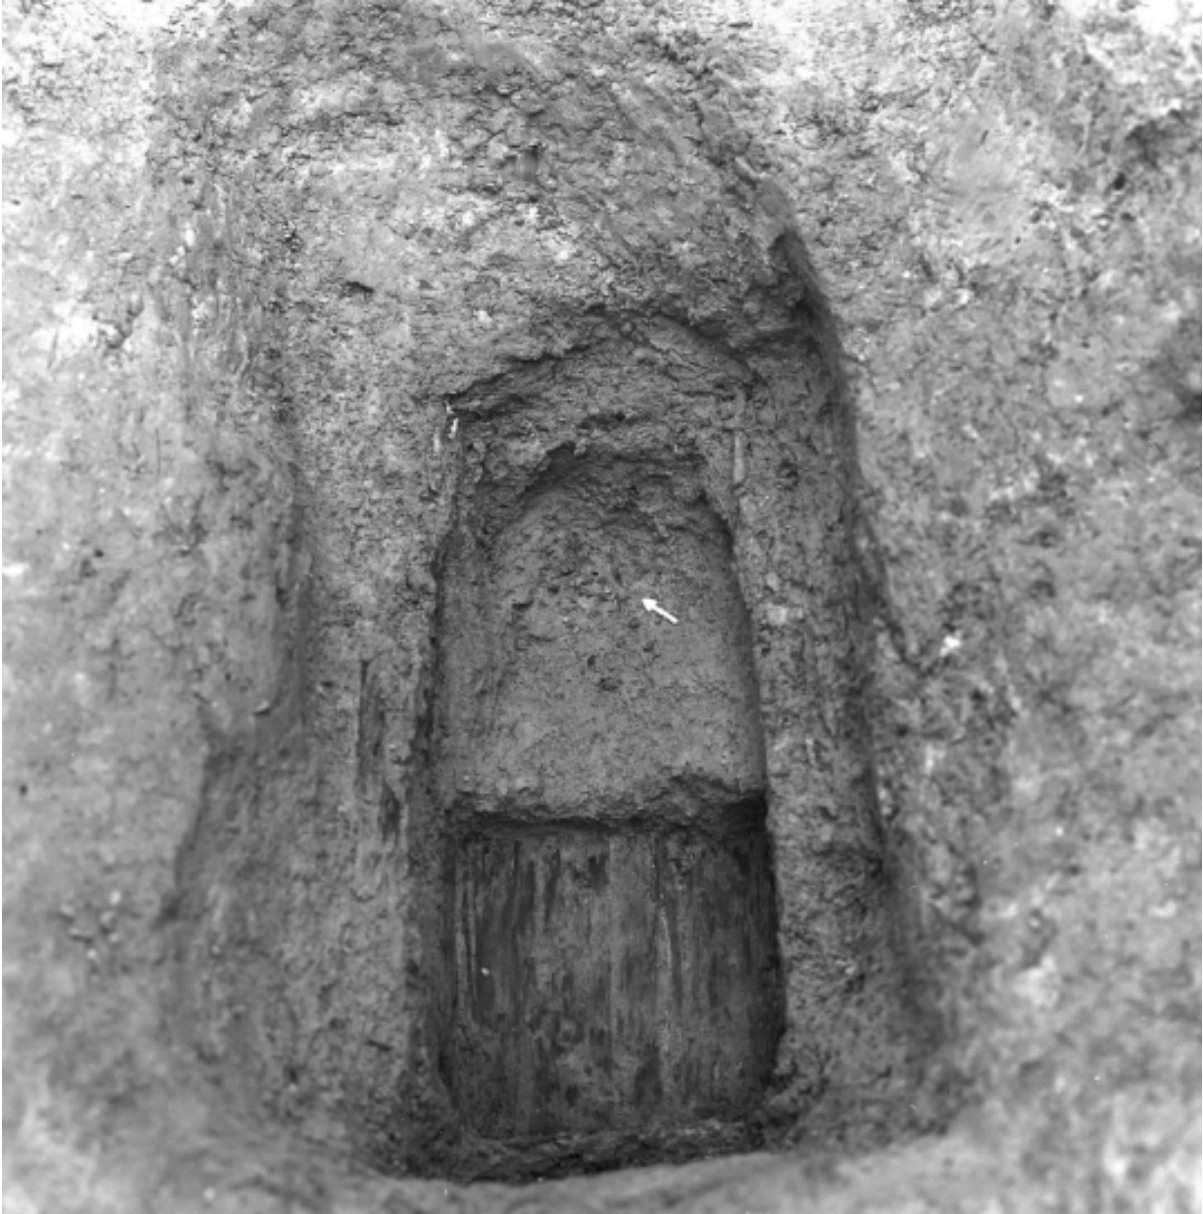
Figure 38. Small box in southern feature. (Arrow indicates location of bone.)

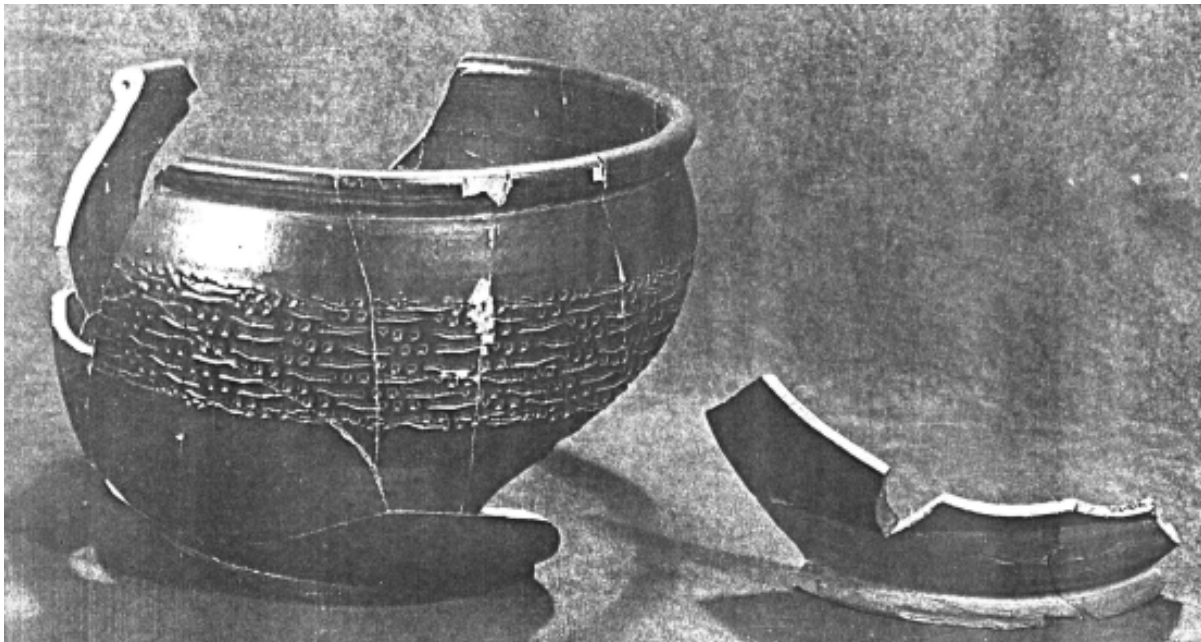
FIGURE 40

Chamber pot, rim to base fragments. This undecorated creamware vessel has a thin-walled refined earthenware body covered by a clear lead glaze on interior and exterior surfaces. The pear-shaped body curves outward from a slightly constricted mouth and through a full-bellied waist to the standing ring. A single vertical strap handle terminal appears on the assembled fragments. Chamber pots of this ware were produced throughout the English pottery centers as early as 1762.

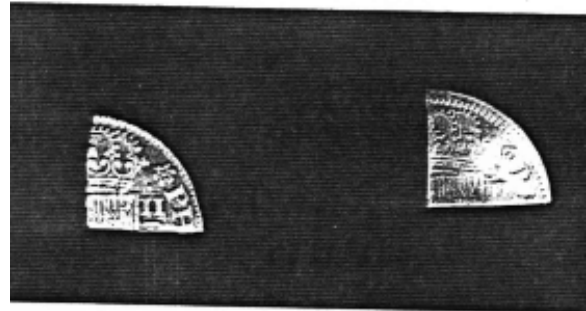
B. Spanish two-reale piece. This is a nearly identical quarter to the one described above. It bears the same portions of the inscriptions and coat of arms. The surface of this quarter displays much more wear, but details of the design are still legible.

Found in redeposited clay fill of west wing cellar.
Catalog # 215.44B-119
Archaeological context: 1835.
